14 Lincoln Place Cinema Building, Madison, NJ

Historic Preservation Review

Thornton Tomasetti Project No. F19022.00

February 11, 2019

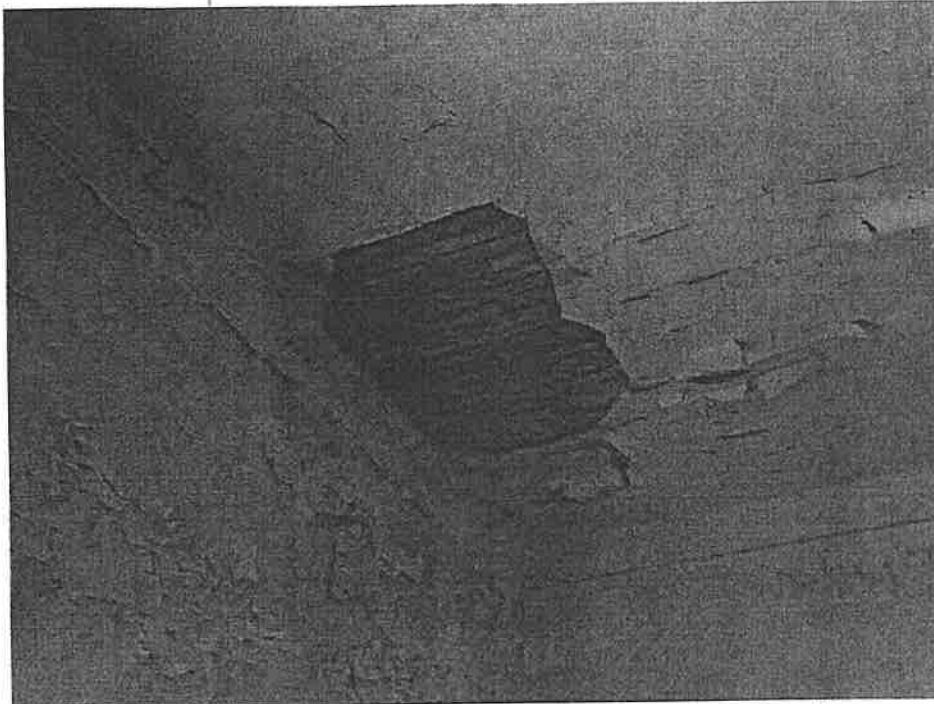
- a. Moisture damage was observed at the plaster finishes throughout the second floor walls and ceilings of the existing building. Many areas have failed and fallen to the floor (see Photos 1-3). A larger percentage have delaminated in place and the majority of plaster finishes are discolored, and have peeling paint due to long term exposure. Plaster and exposed areas of wood lath are currently moist due to wall and roof infiltration.

- a. Moisture damage has largely destroyed or compromised the interior finishes in much of the existing building. Moisture infiltration has been occurring for decades and is currently active. Moisture has infiltrated the second floor in quantities sufficient that it has continued down and damaged the first floor finishes, particularly the theater ceilings. Extensive reconstruction would be required for the existing building to be safe and usable.

Photo 1: Failed, delaminated and moist plaster at 2nd Floor ceiling and walls. Note water damaged, deflected wood lath.

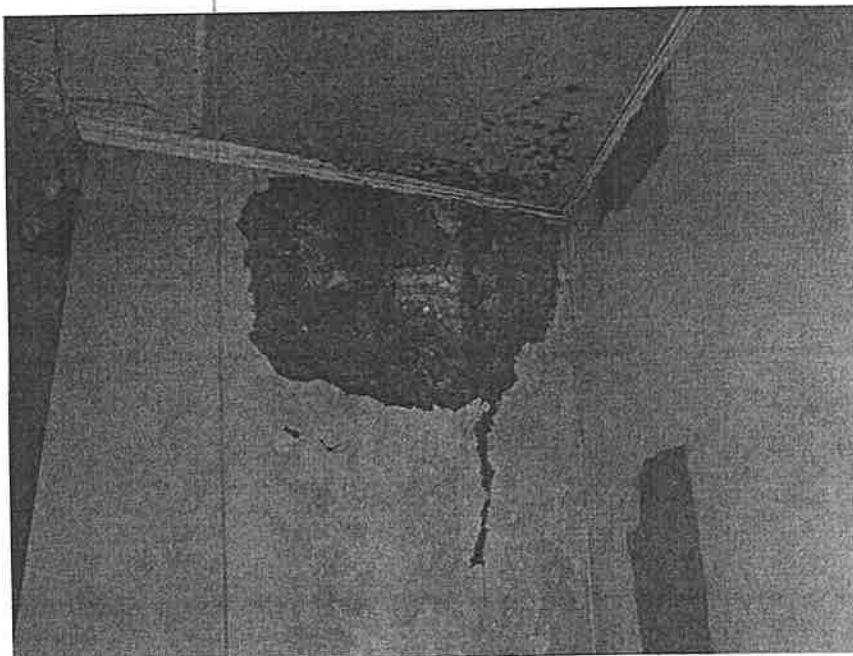
Photo 2: Failed, delaminated and moist plaster at 2nd Floor. Note mold growth at ceiling area previously patched with gypsum board.

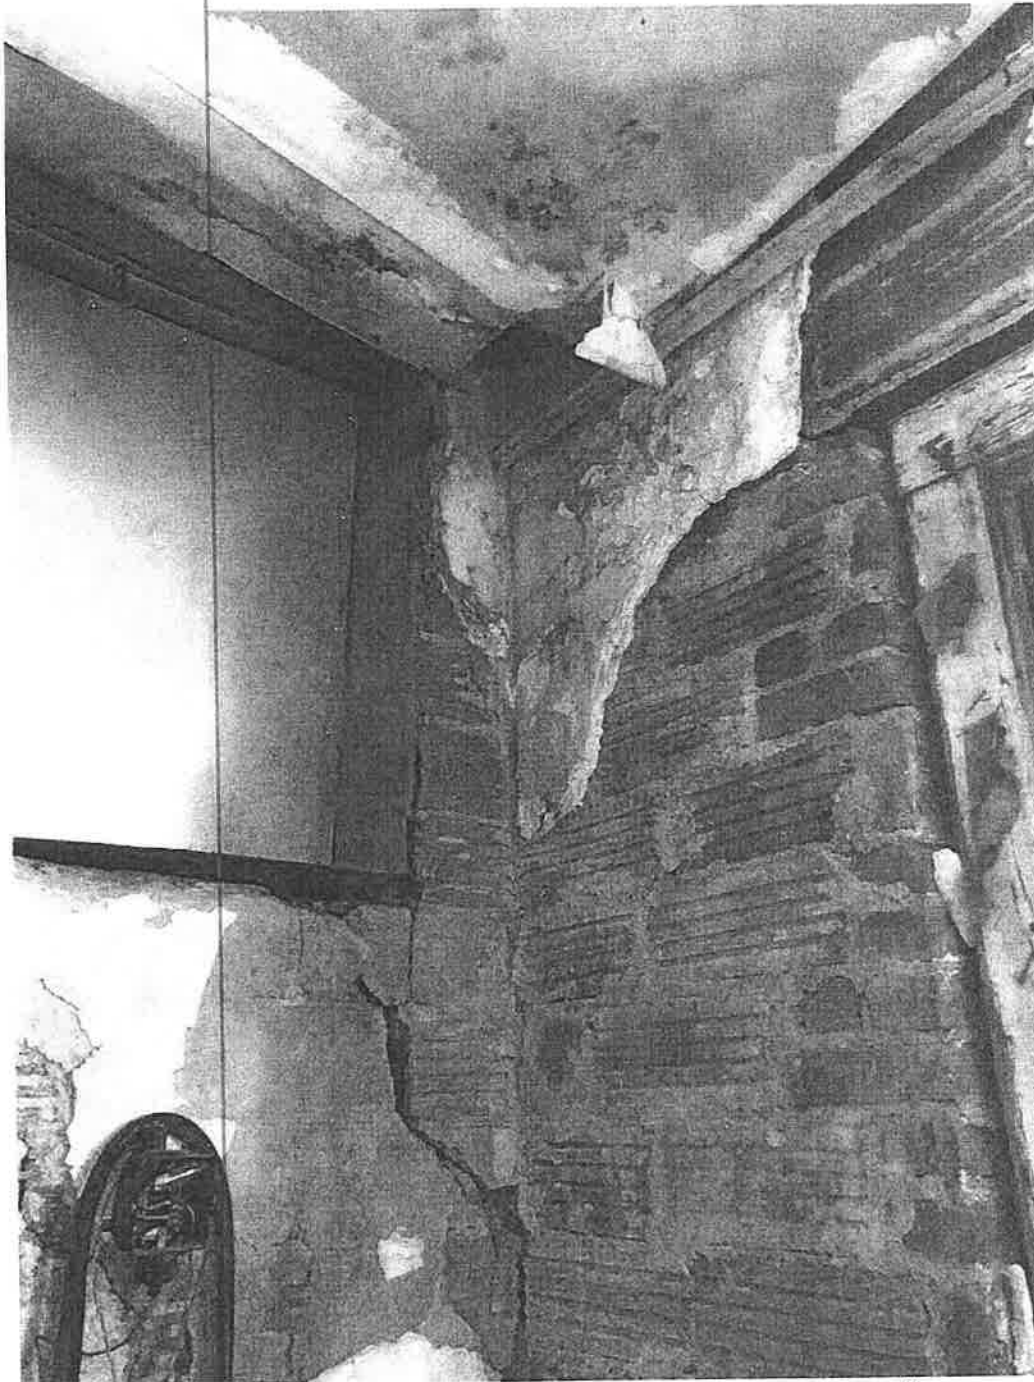
Photo 3: Failed plaster at structural cracking at 2nd Floor. Note mold growth at ceiling area previously patched with gypsum board.

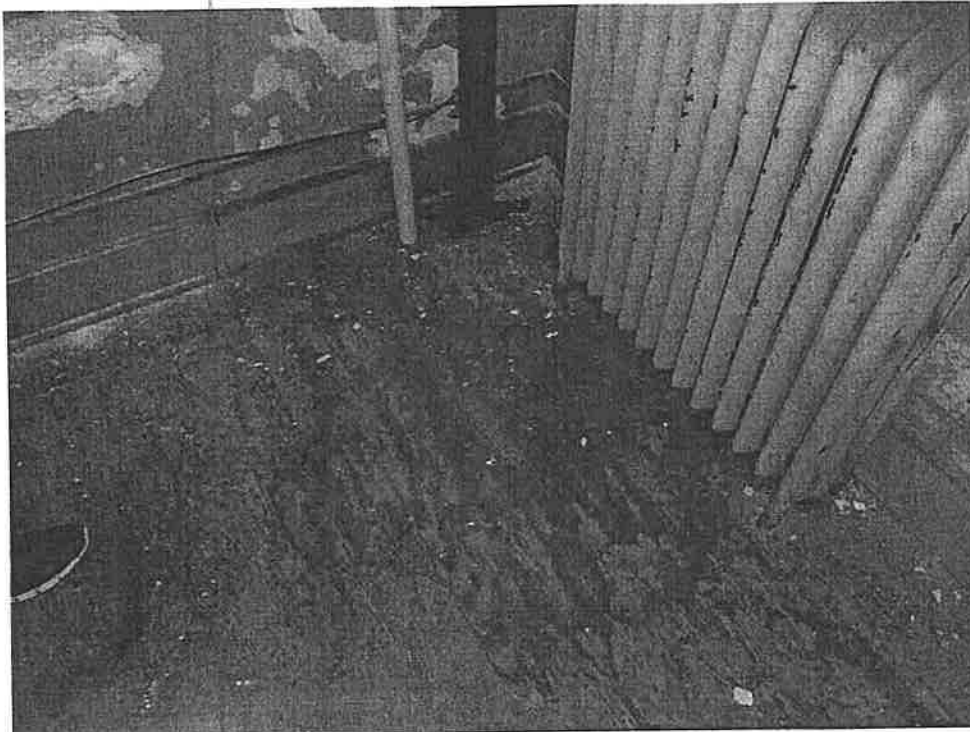
- b. Moisture damage was observed at flooring throughout the second floor, including staining, warping and softening of subflooring (see Photos 4-6). Moisture is active and is finding a path through to the ceiling of the ground floor.

Photo 4: Moisture damaged flooring at 2nd Floor.

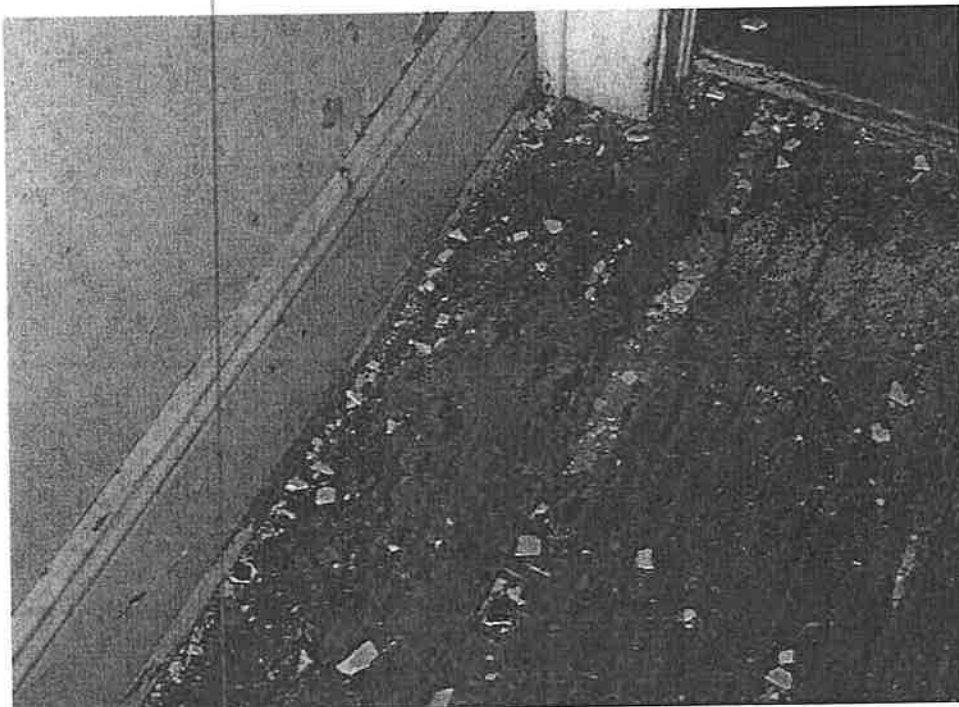
Photo 5: Moisture damaged flooring with soft subflooring at 2nd Floor.

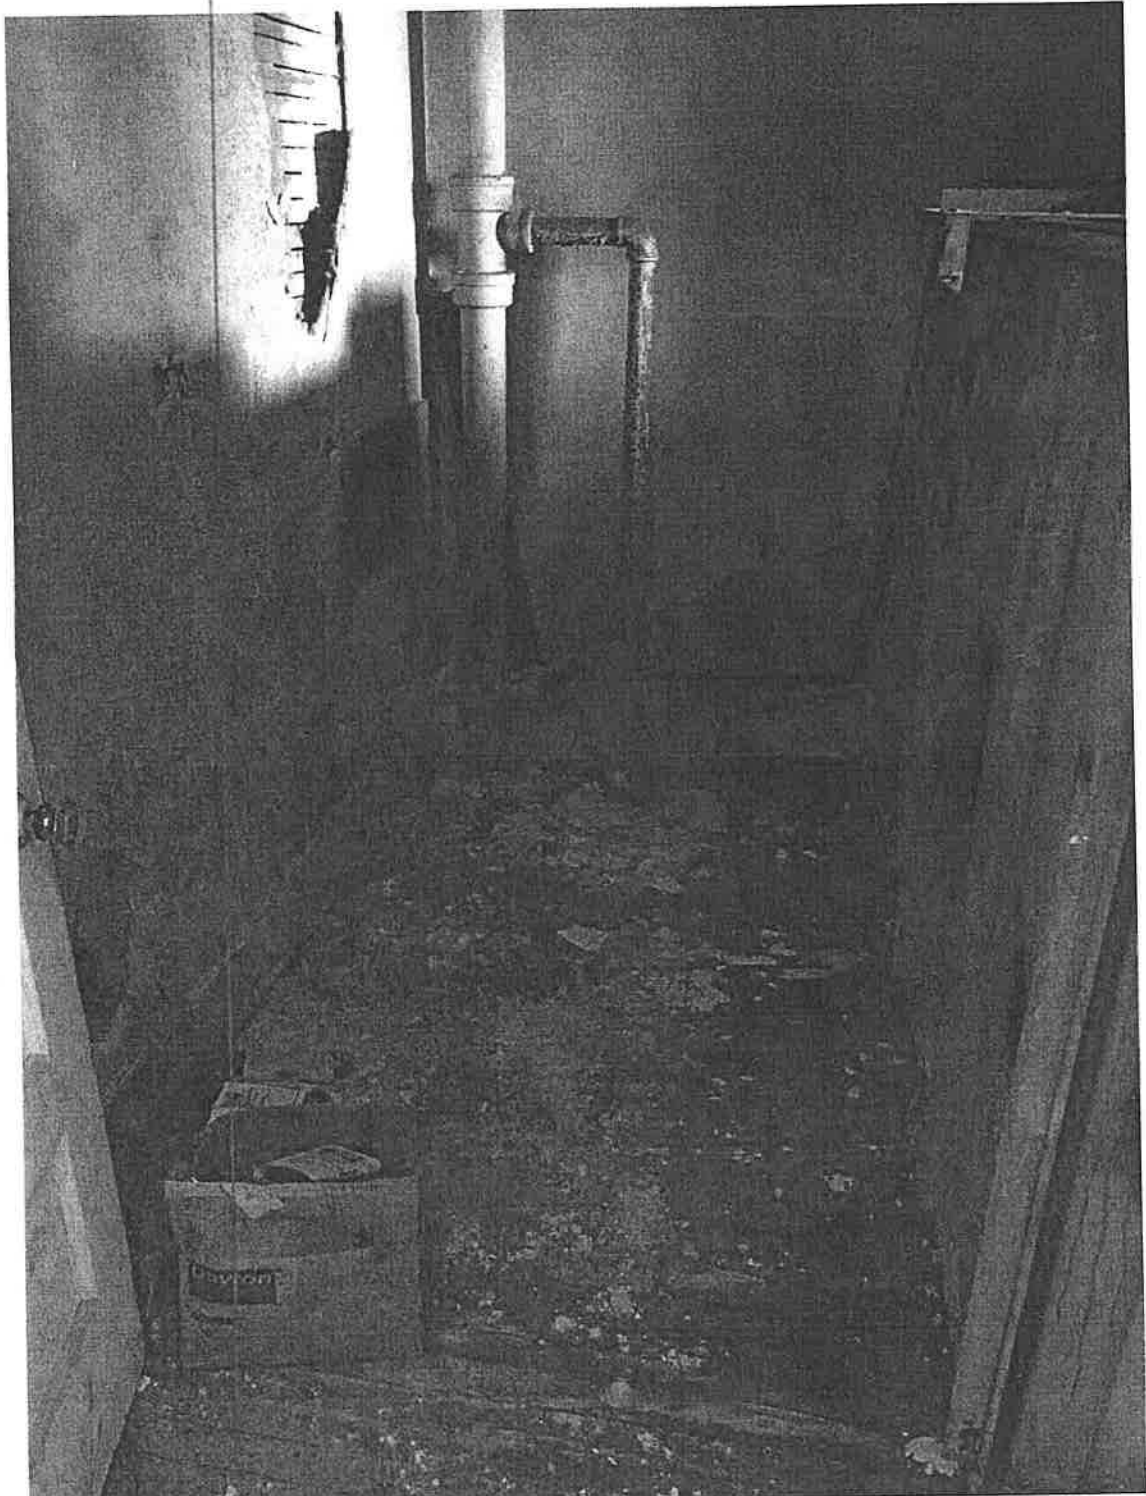
Photo 6: Moisture damaged, soft flooring at 2nd Floor. Note wall/ceiling plaster failure and debris.

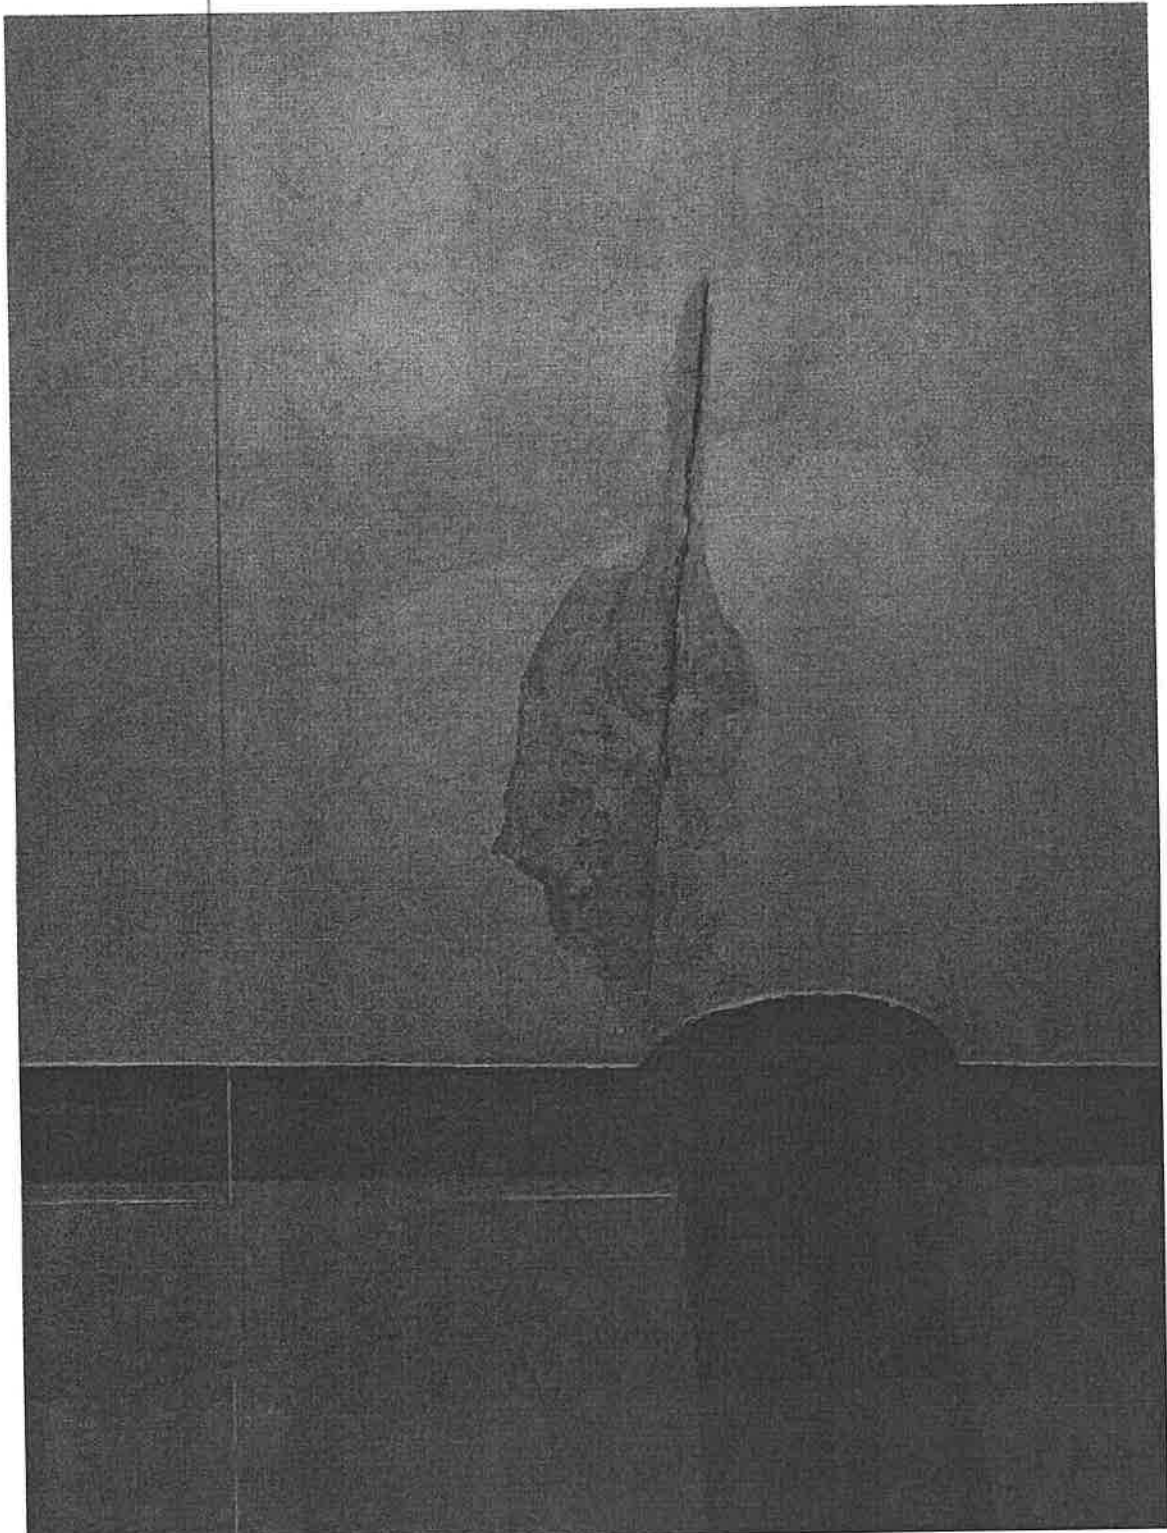
- c. Moisture damage was observed at the first floor ceiling, at lobby areas (see Photos 7-9) and in the theaters. In the theaters, there are suspended acoustical ceilings beneath the original ornamental plaster ceilings. There are a number of areas where acoustical panels have fallen due to falling plaster from above, the weight of saturated fiberglass insulation and other causes (see Photo 10). Visible areas of ornamental plaster are moisture damaged and appear friable.

Photo 7: Moisture damage at lobby ceiling.

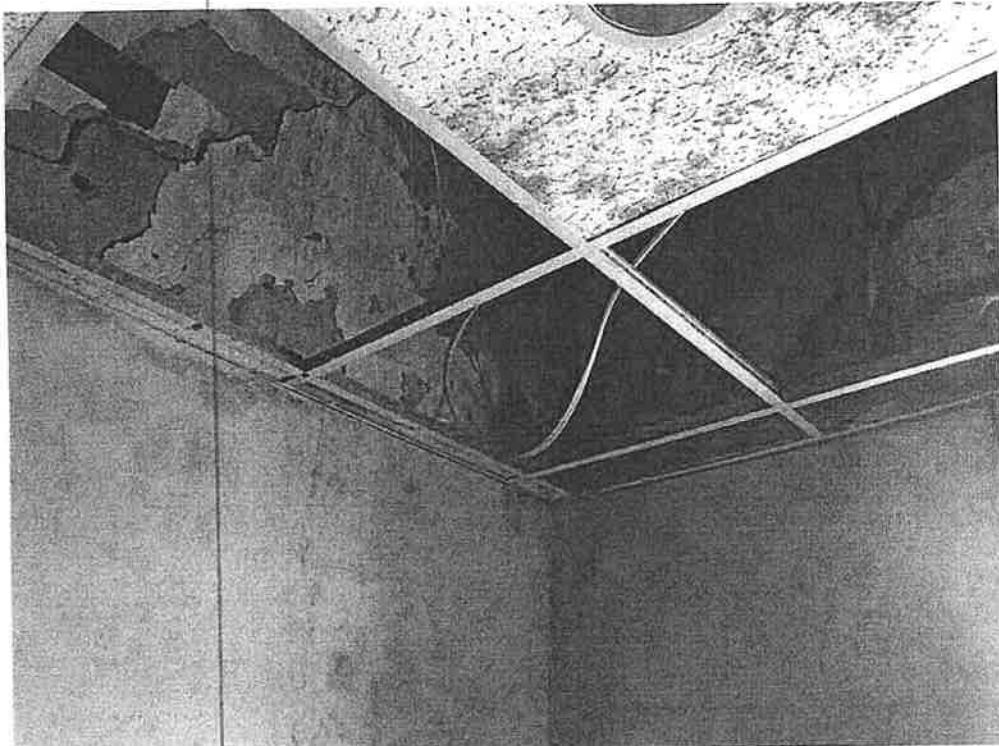
Photo 8: Moisture damage at lobby walls and ceiling. Note apparent mold growth.

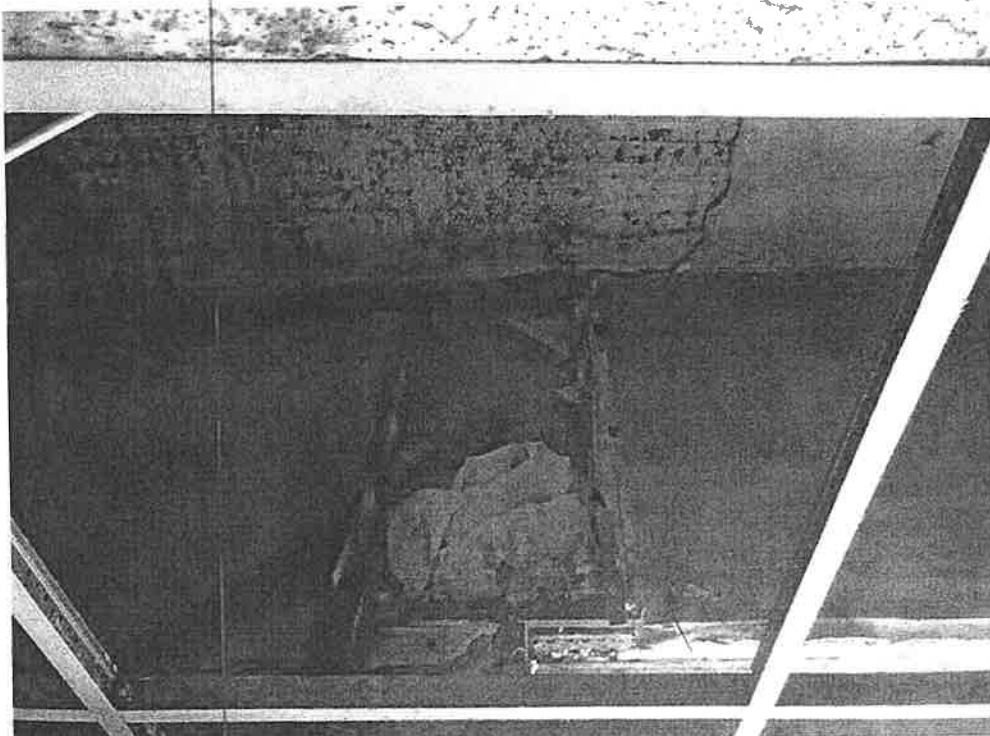
Photo 9: Moisture damage at lobby walls and ceiling. Note apparent mold growth.

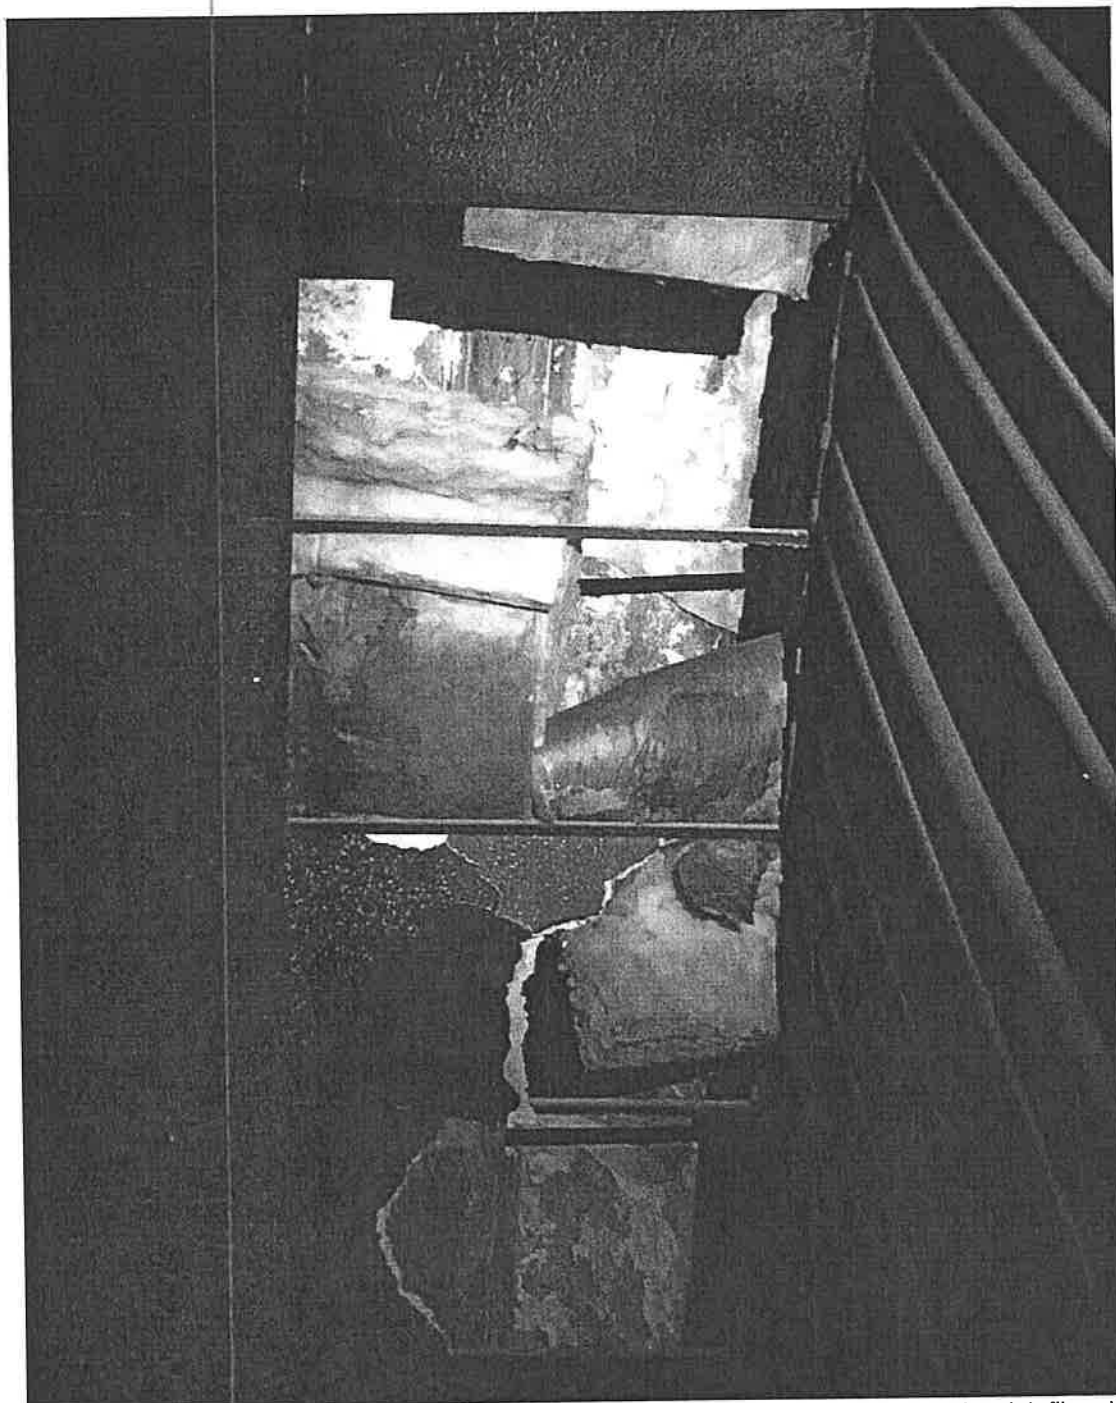
Photo 10: View up at theater ceiling. Where damaged acoustical tiles have fallen, moist pink fiberglass insulation is visible and beyond, original ornamental plaster is moisture damaged and friable.

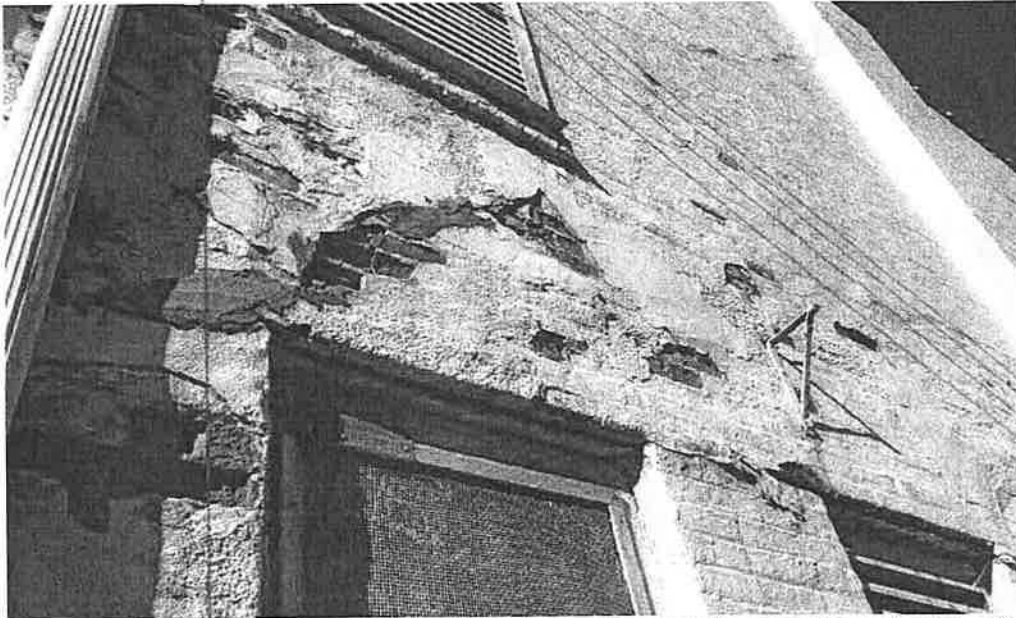
- d. Exterior brick masonry at the stage house and the office side walls is in poor condition. The original red face brick of the stage house has been coated with layers of white cementitious coating and paint. This appears to have been done in lieu of providing proper maintenance like repointing. The result is that the low permeability of the coating has caused the brick to retain moisture and experience freeze thaw damage. Spalling brick and cracked, decaying brick and mortar were observed all around the stage house at areas where the coating is cracked and failing (see Photos 11-13). The brick damage is only visible at areas where the coating has spalled off, but the condition is widespread beneath the coating throughout.

- b. The exterior brick of the stage house and office side walls has cracking due to structural failures. It has localized cracking due to moisture infiltration, freeze thaw and thermal movement. There is a pattern of spalling that is a symptom of widespread disintegration of the face brick and mortar beneath the multiple layers of coatings. This is contributing to the structural deficiencies of the wall and has resulted in a condition where moisture infiltrates the exterior wall throughout the building. Because the damage to the face brick is so widespread, there are no good options for restoring the exterior walls without large scale brick removal and replacement. The brick damage appears too widespread for removal of the coatings and proper repointing to succeed. Applications of an additional coating along with spot repairs might temporarily reduce moisture infiltration, but would essentially continue the current course and would not have a sufficient service life for a project with the investment required to bring the existing building back to a usable condition.

Photo 11: Stage House side wall with multiple layers of cementitious coating and paint, with extensive spalling and cracking of brick masonry. Brick damage is widespread beneath coating.

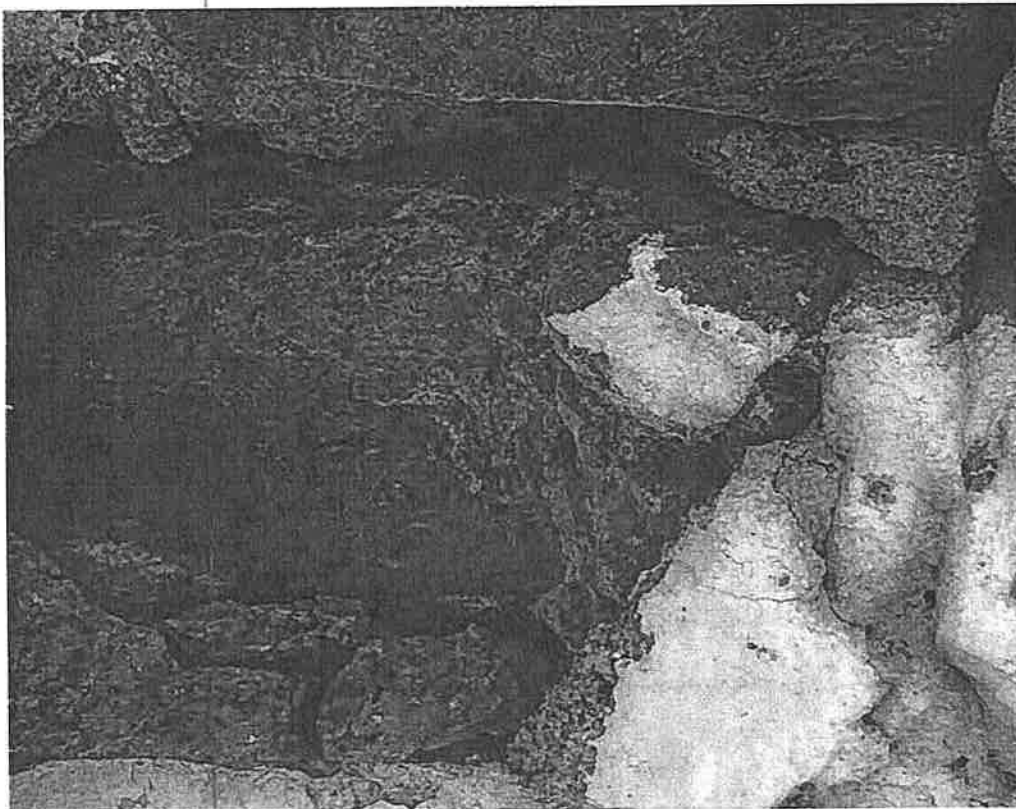
Photo 12: Close up of brick at side wall spall, showing freeze thaw damage to brick and cracked mortar.

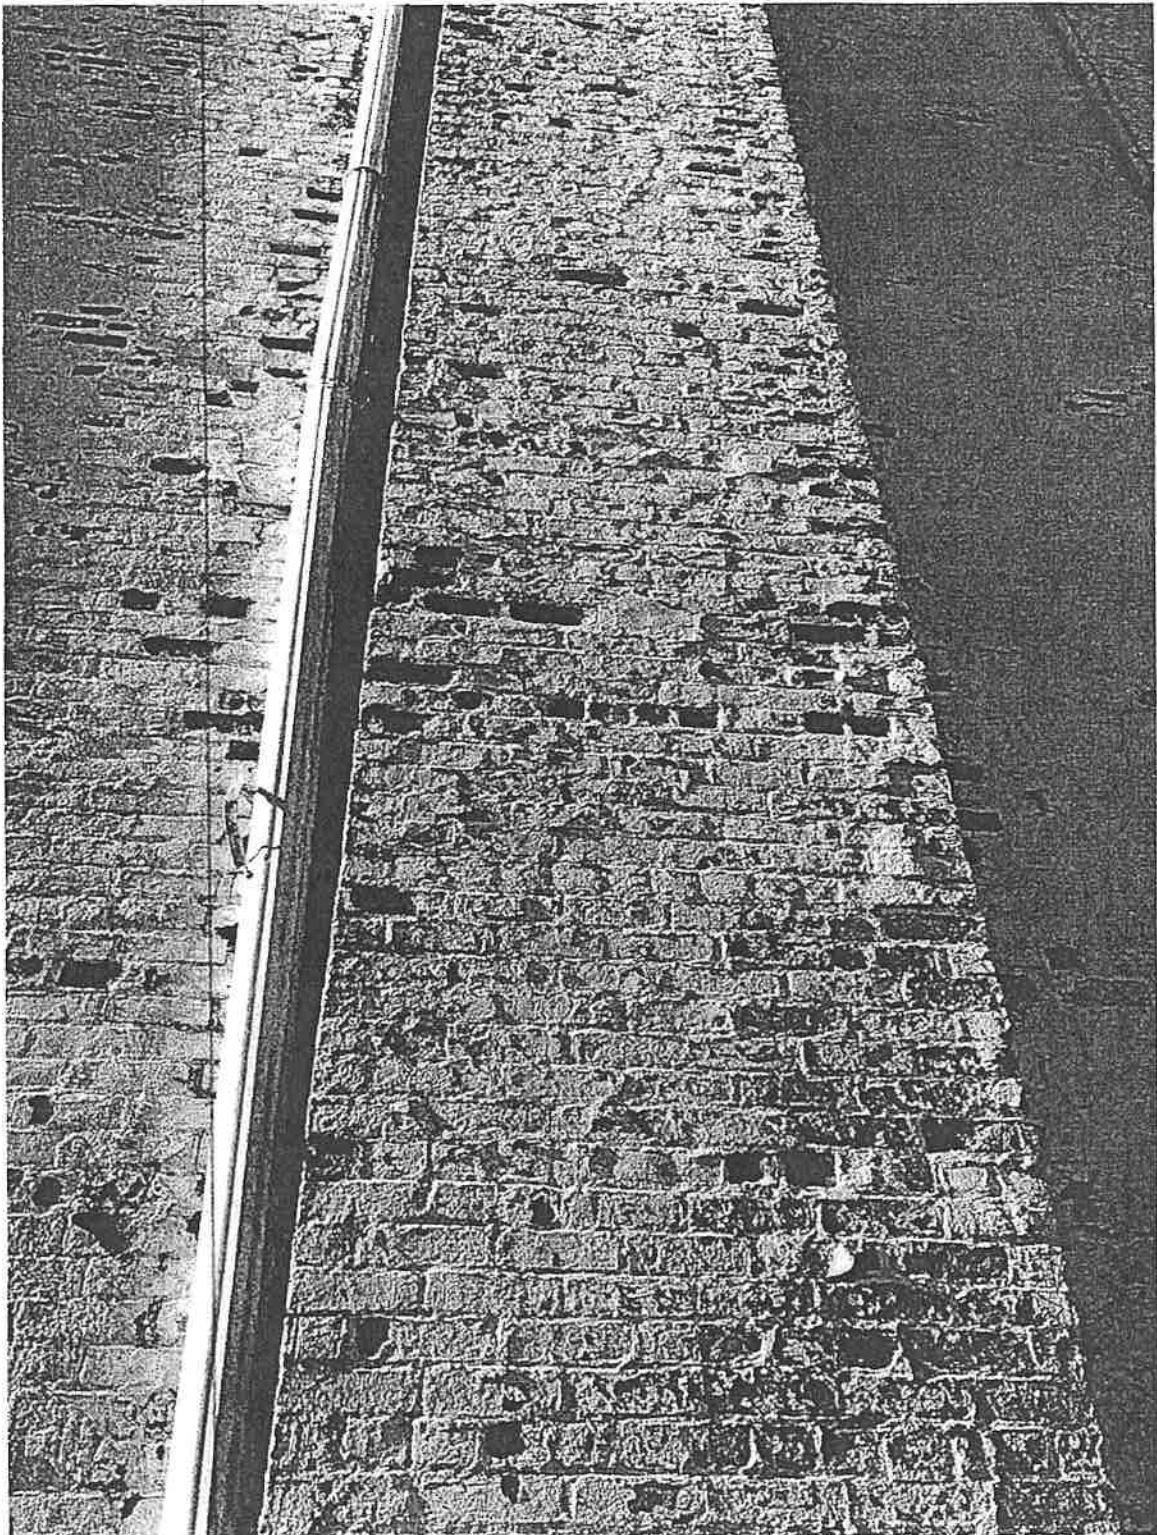
Photo 13: Typical brick failure at side wall of stage house.

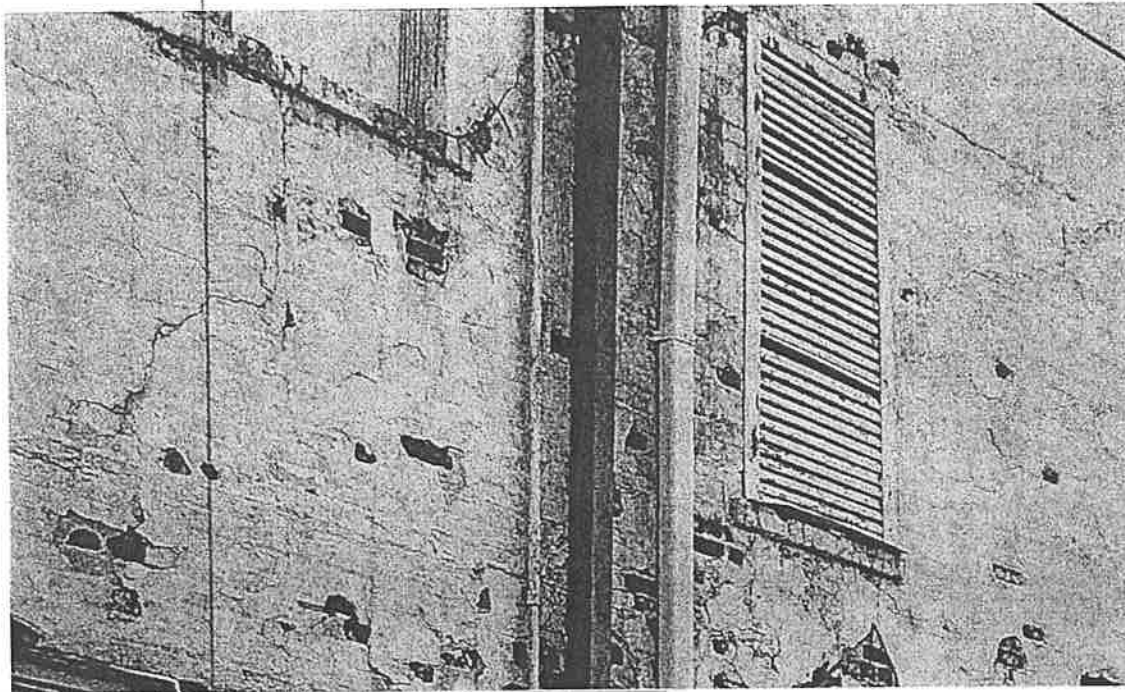
There is also extensive cracking through the brick masonry, some at areas of structural cracks, some at areas like corners of window frames, but there is also extensive multidirectional network cracking throughout, some through the coating and some through the masonry, due to thermal and moisture stresses (see Photo 14). Because the walls are built compositely, with the face brick bonded to the backup terra cotta block, cracks telegraph through the entire masonry wall and contribute to moisture infiltration throughout. Based on the extent of interior moisture damage and ongoing infiltration, it appears that the multiple layers of coatings have not abated infiltration and appear to

Photo 14: Network cracking, locally in coating and/or brick masonry.

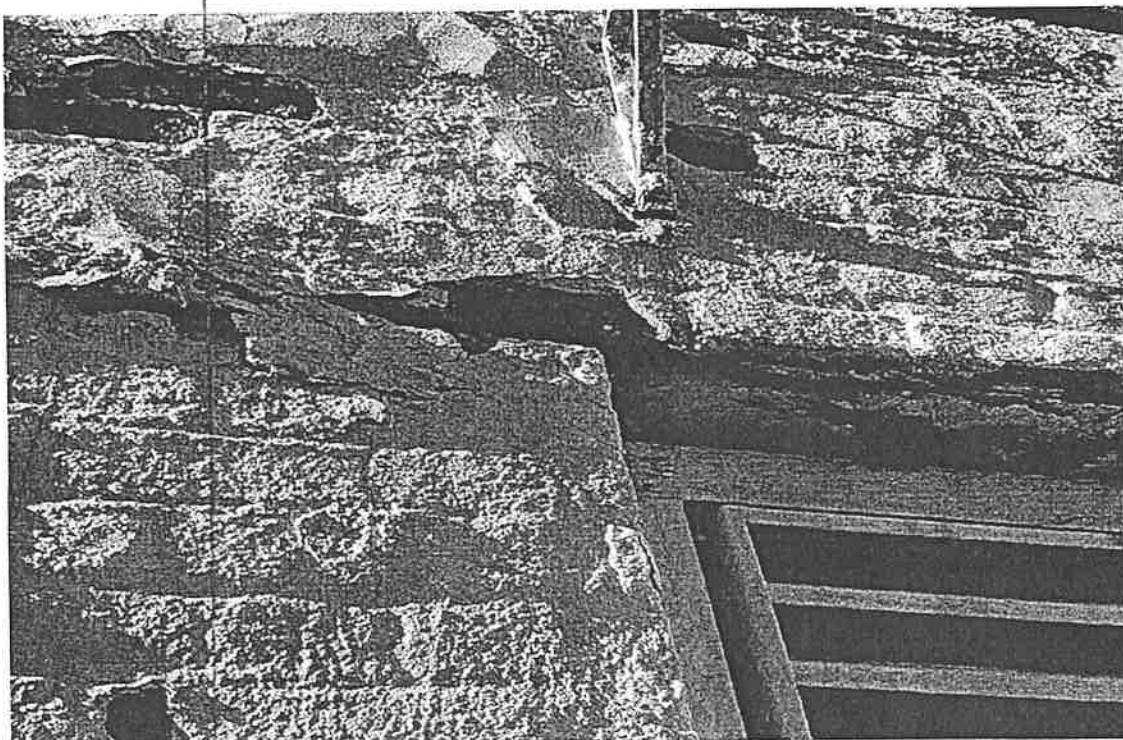
have contributed to widespread failure of the wall as a moisture barrier and greatly diminished the material integrity of the face brick. Ferrous metal items such as lintels have corroded throughout. Some have bowed and/or delaminated and many have rust jacking that has damaged bearing masonry at the jambs (see Photo 15).

Photo 15: Corroded lintel at louver opening. Steel is bowed, delaminated and has caused damage to masonry at the jamb from rust jacking.
