14 Lincoln Place Cinema Building, Madison, NJ

Structural Review

Thornton Tomasetti Project No. F19022.00

February 8, 2019

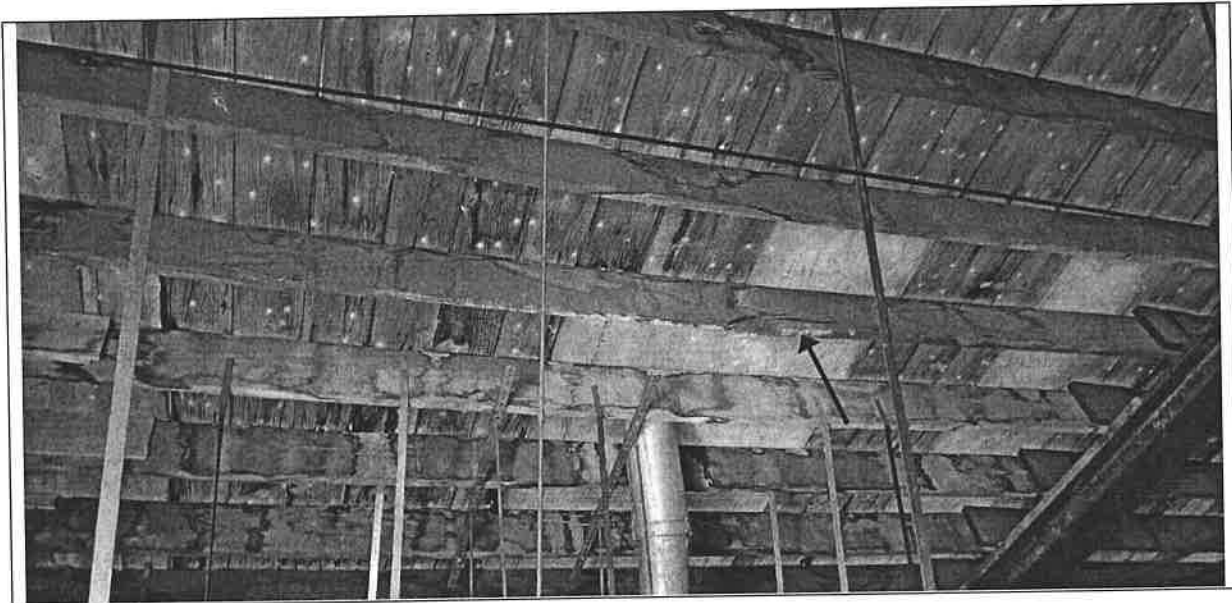
1. *Sagging/Cracked Roof Joists on Sloped Roof:* The wood roof joists that span to the steel roof trusses are significantly deflected, and in some instances are cracked. Refer to Photo 1. —

The joists appear to be sagging as a result of short term and long term (creep) deflections under the weight of the roof structure and plaster ceiling suspended from the joists. These 2x10 joists span 17', which is unusually long for this joist size. TT structurally analyzed the joists and found that they would be significantly overstressed when carrying code prescribed snow loads.

Photo 1: Roof Joists on Sloped Roof: Note significant deflection (typical), and cracked joist at arrow.

1. *Sagging/Cracked Roof Joists on Sloped Roof:* The significantly deflected and overstressed joists on the sloped roof are structurally deficient and should be removed and replaced. This would also require removing and replacing the roof sheathing and shingles, and temporarily supporting the suspended plaster ceiling.

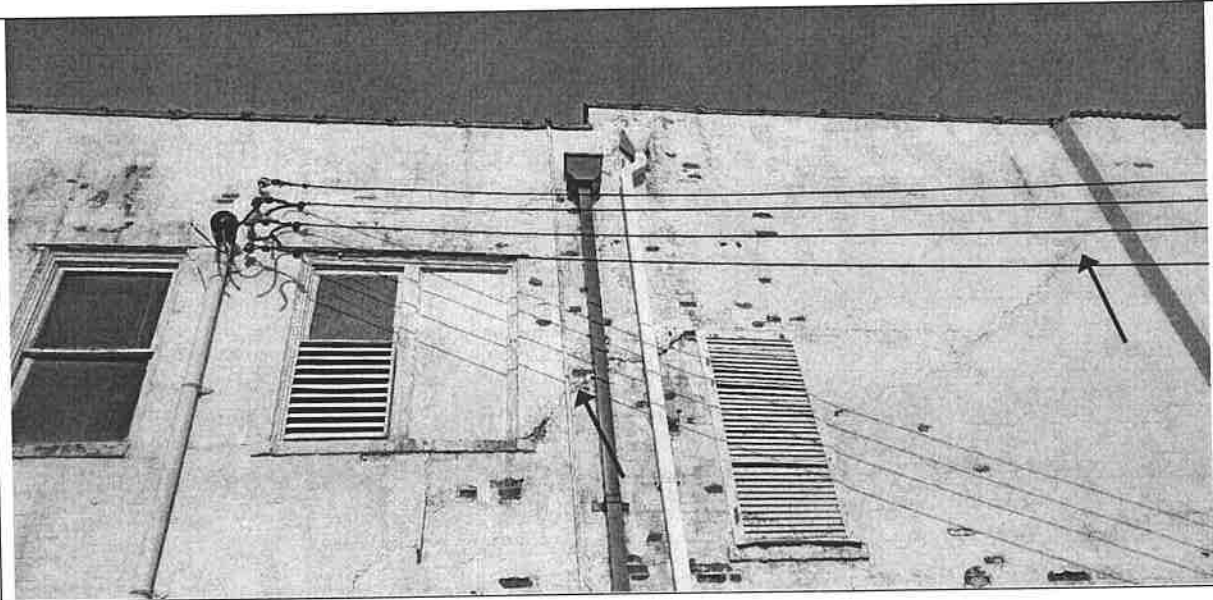
3. *Structurally Cracked Section of East Exterior Wall and Supporting Concrete Foundation:* A large section of the east exterior wall has a number of structural diagonal cracks from bottom to top of the wall, including through the brick piers that support the roof trusses, and through the concrete foundation itself. Refer to Photos 2 – 4, and 10.

The configuration and size of these structural cracks indicate that a portion of the supporting wall foundation has settled. The observed cracking and settlement have structurally compromised: 1) a substantial section of the east wall, which laterally stabilizes the building; and 2) a brick pier that supports a roof truss.

Photo 2: East Exterior Wall: Note significant structural diagonal cracks.

3. *Structurally Cracked Section of East Exterior Wall:* The soil under the wall's foundation should be investigated with test pits and soil borings to determine whether the wall is at risk of continuing settlement. If necessary, the foundation should be stabilized with soil grouting, mini piles or

other suitable means. Regardless of whether foundation stabilization is required, the cracked masonry should be selectively removed and replaced.

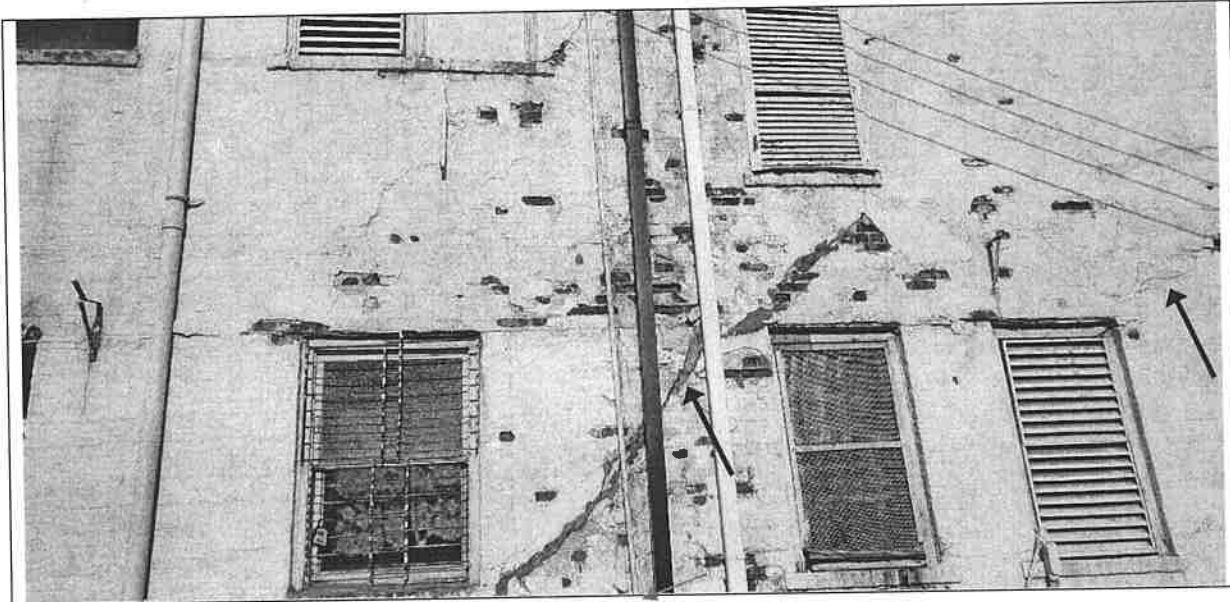
Photo 3: East Exterior Wall: Note significant structural diagonal cracks.

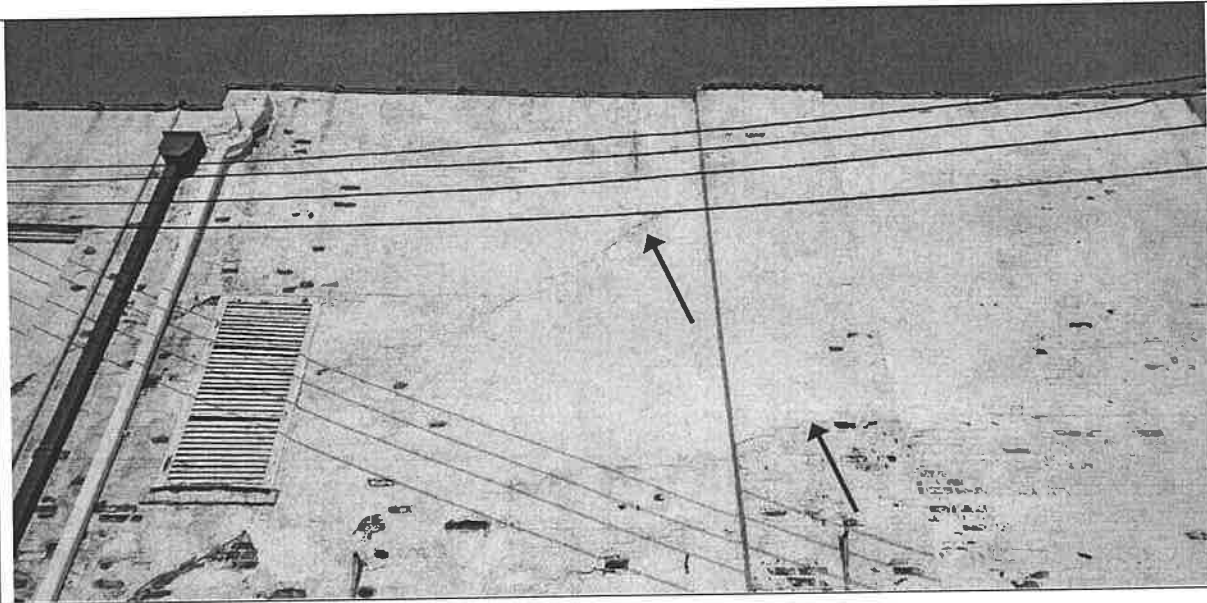
Photo 4: East Exterior Wall: Note significant structural diagonal cracks.

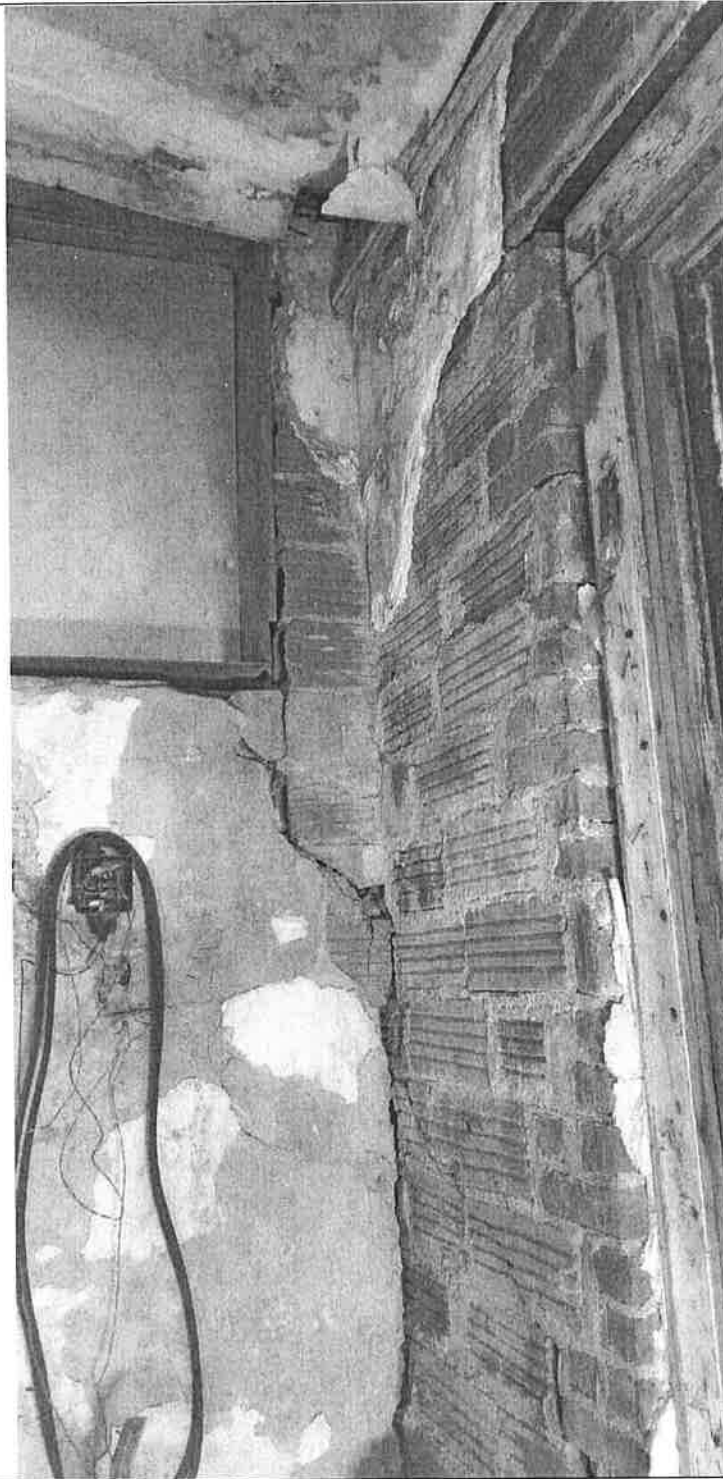
4. *Structurally Cracked Section of East Side of Interior Bearing Wall:* A large section of the interior bearing wall below the south gable of the sloped roof is structurally cracked near the east side. Refer to Photos 5 – 6.

The size of these structural cracks and proximity to the settled section of the east exterior wall suggest that this section of wall may have been damaged by foundation settlement as well. The

observed cracking has structurally compromised the end section of this wall, which laterally stabilizes the building and provides vertical support for the roof.

Photo 3: East End of Interior Bearing Wall below South Gable: Note significant structural cracks.

4. *Structurally Cracked Section of East Side of Interior Bearing Wall:* The soil under the wall's foundation should be investigated with test pits and soil borings to determine whether the wall is at risk of continuing settlement. If necessary, the foundation should be stabilized with soil grouting, mini piles or other suitable means. Regardless of whether foundation stabilization is required, the cracked masonry should be selectively removed and replaced.

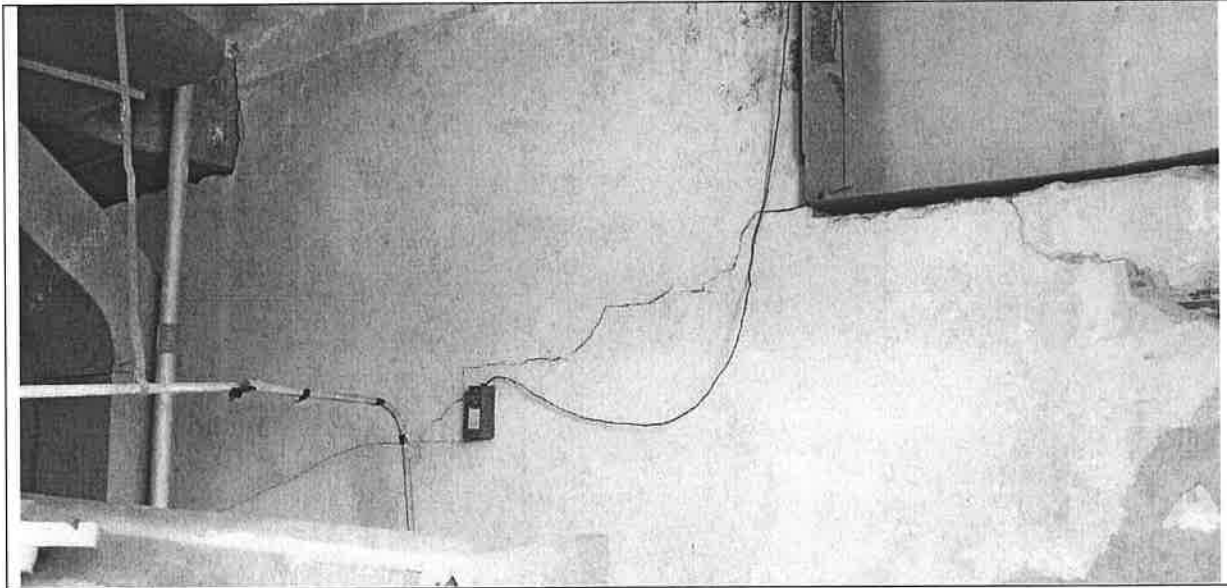
Photo 6: East End of Interior Bearing Wall below South Gable: Note significant structural cracks.

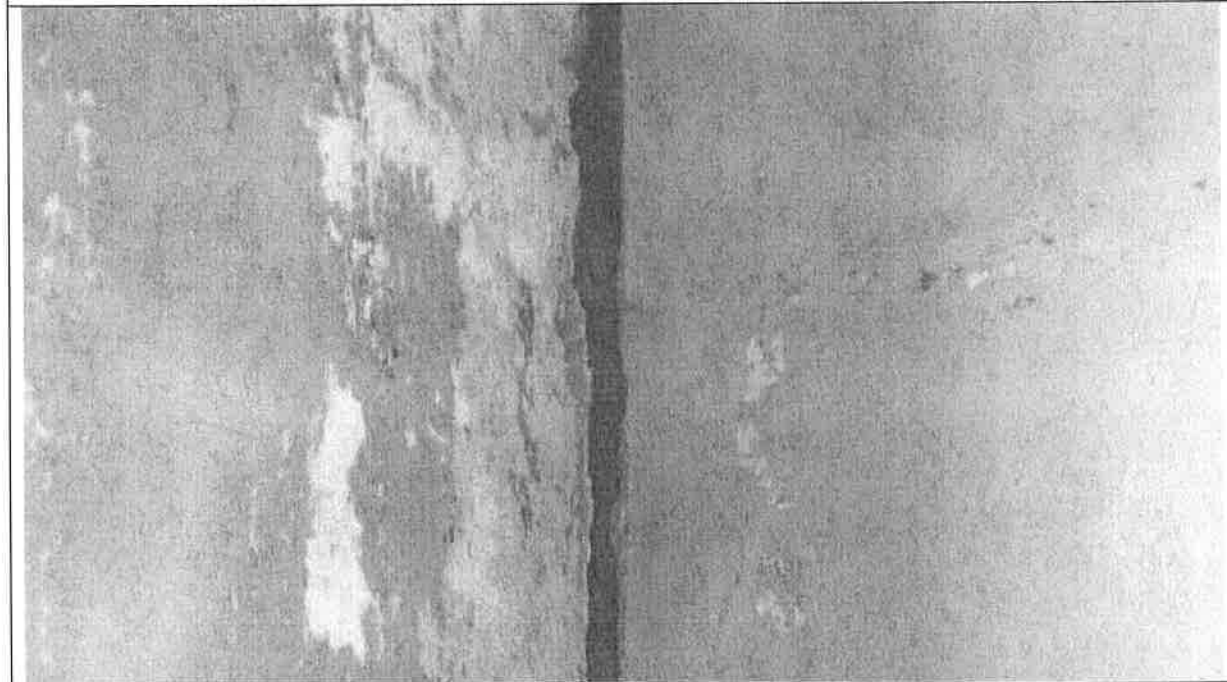
5. *Out of Plane Displacement and Cracking of Exterior Walls:* TT and Persimmon observed a number of locations where the exterior walls have displaced outward at their tops as evidenced by the walls separating from perpendicular walls. Refer to Photos 7 – 8. Locations were also observed where the exterior walls/piers have horizontal cracks. Refer to Photo 9.

The observed displacements indicate that the walls are not adequately anchored at their tops to resist out of plane forces. The observed horizontal cracks may be an indication that the walls are bowing outward between horizontal anchor points at the foundation and roof. These displacements and cracks have structurally compromised the exterior walls, which laterally stabilize the building and provide vertical support for the roof.

Photo 7: End of Interior Bearing Wall at Face of East Exterior Wall – Note separation indicative of out of plane wall displacement.

5. *Out of Plane Displacement and Cracking of Exterior Walls:* The out of plane displacement and cracking should be investigated and stabilized as required by adding anchors to better tie the walls back to the roof structure and perpendicular walls, and by reinforcing the brick piers to better resist out of plane forces. *How much out of plane*

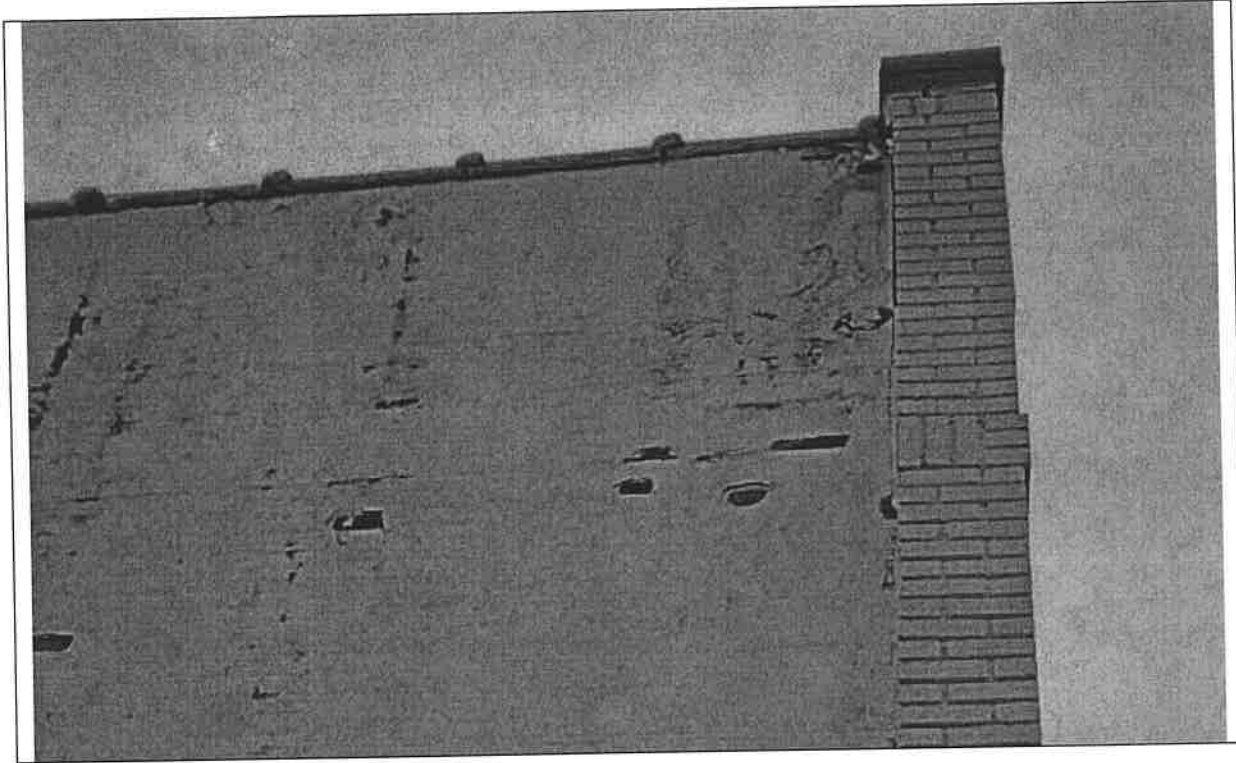
Photo 8: West End of South Exterior Wall: Note separation indicative of out of plane wall displacement.

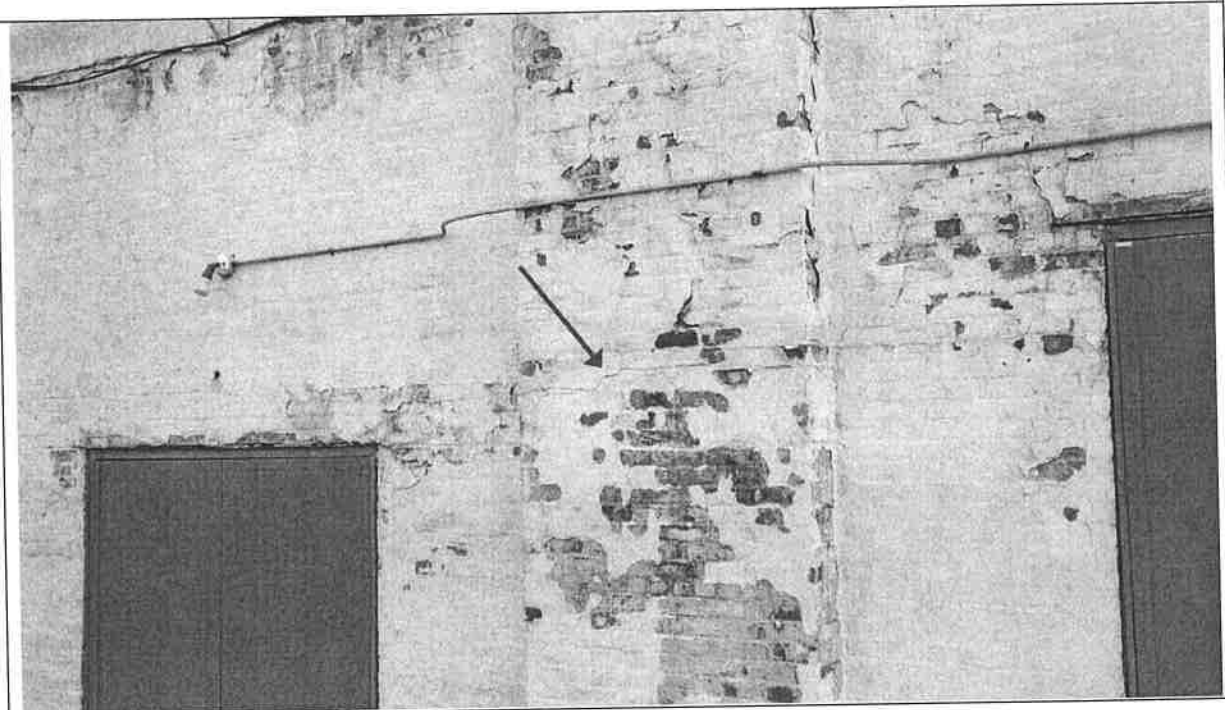
Photo 9: Brick Pier on West Exterior Wall: Note horizontal crack.

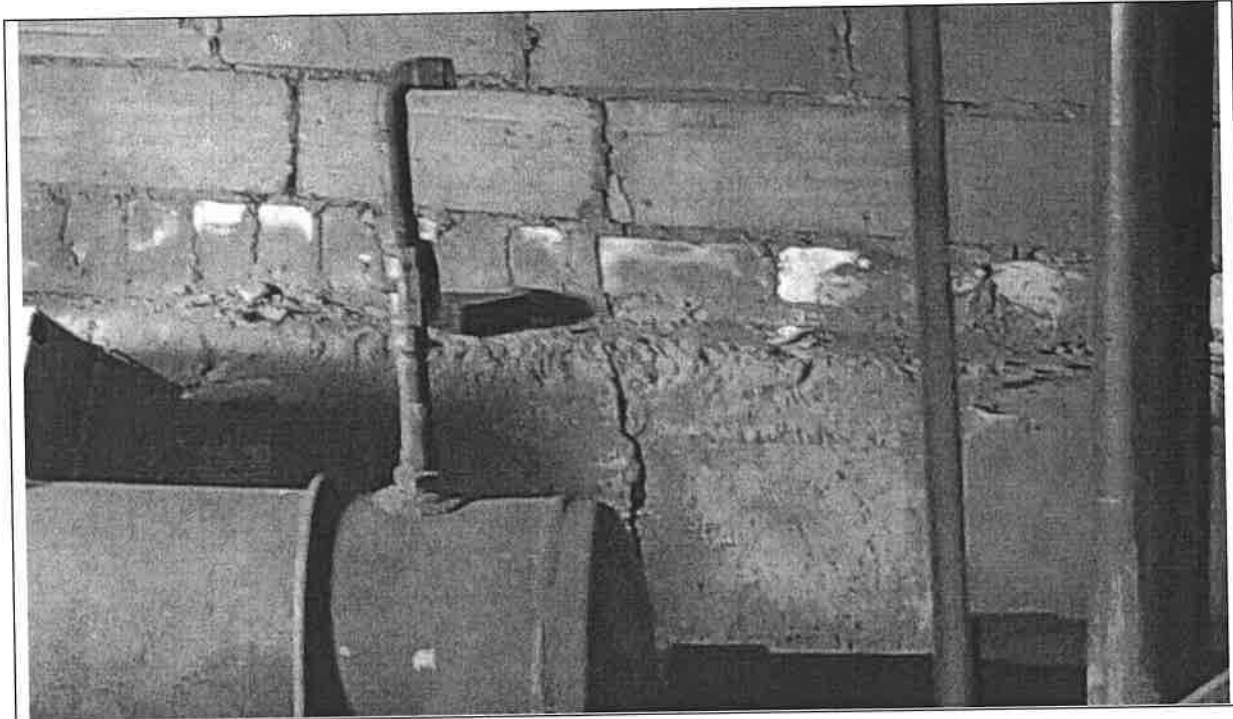
Photo 10: Inside face of concrete foundation for East Exterior Wall: Note large vertical crack in concrete foundation propagates into terra cotta masonry.
